## Home Inspection Report

PROPERTY INSPECTED:  
**109 Glenmore Road**  
**Toronto, ON M4L 3M2**

**Date of Inspection: 11/27/2024**

Inspection No. 141465-1168

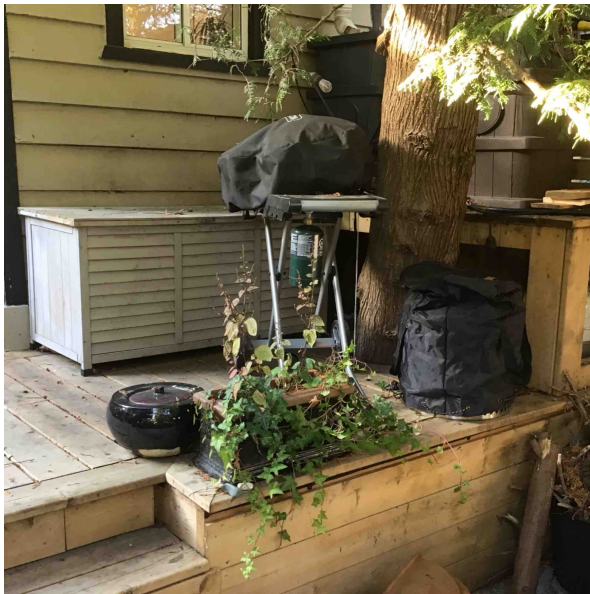
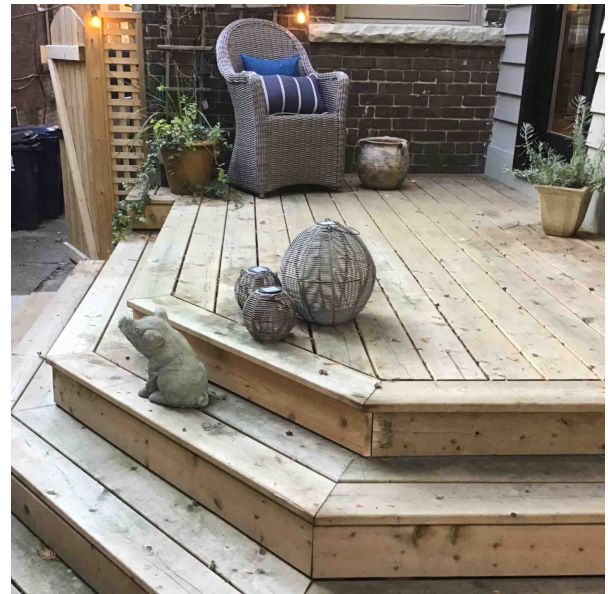
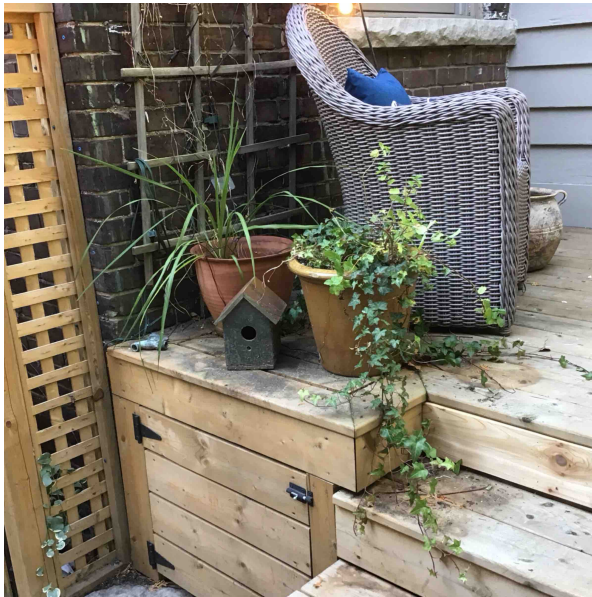
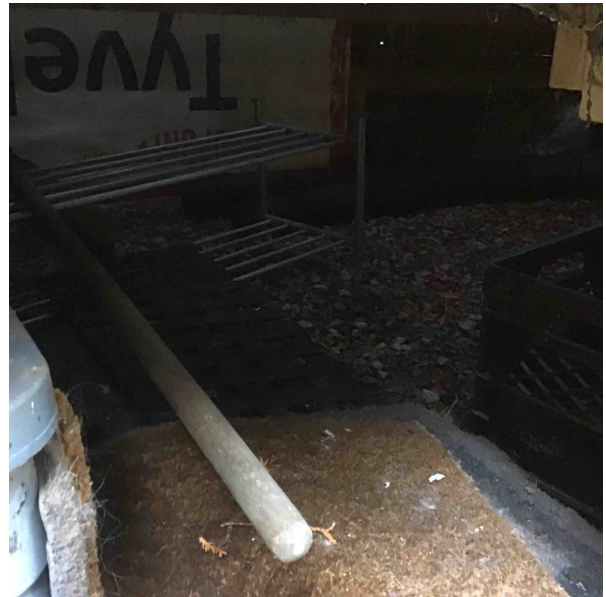
3.10.2 The deck is missing guard/handrails. Install where required to prevent injury and improve safety. **(Rear Deck)**

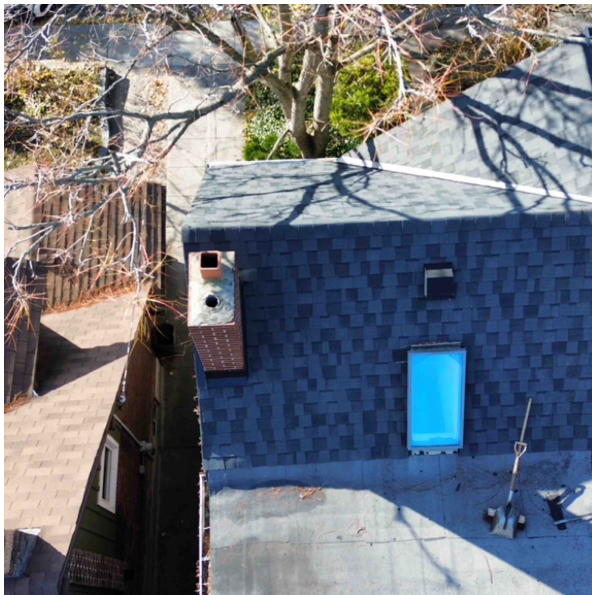
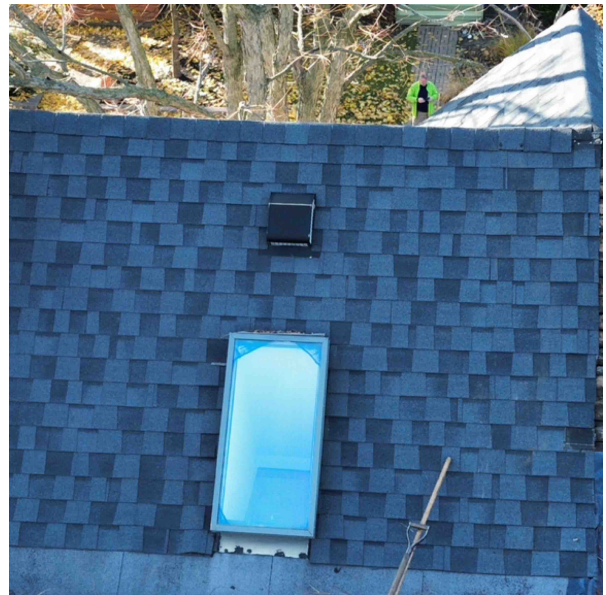
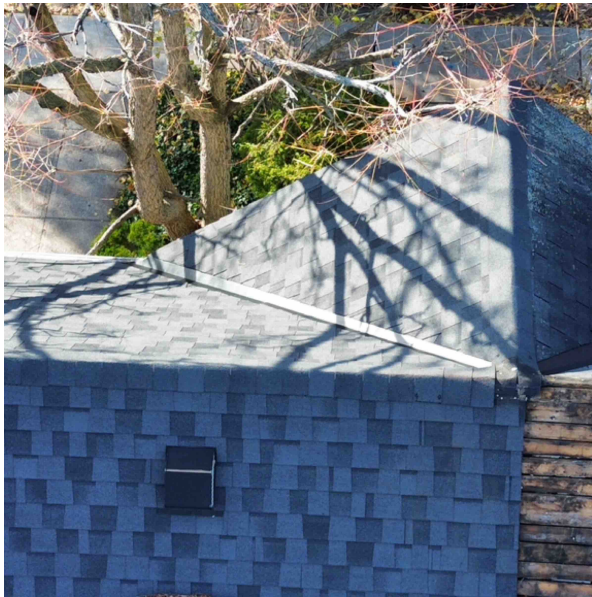
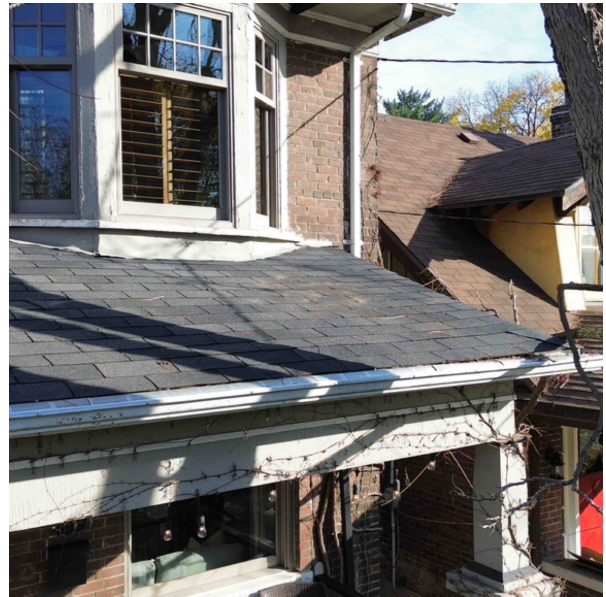
4.3.1 The sloped roof is between the beginning to middle of its lifespan

4.3.2 Portions of the dwelling is covered with laminated shingles, also known as architectural roof shingles or three-dimensional shingles, are thick, double-layered fiberglass roofing shingles that offer a bold and visually striking aesthetic to the roof system.

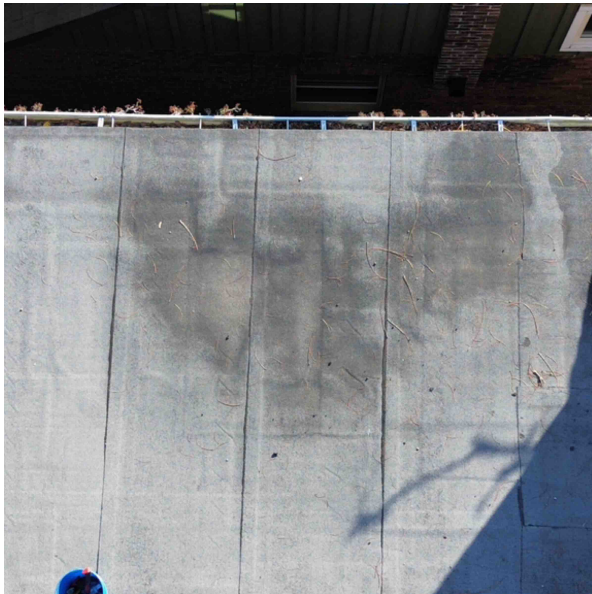
Water ponding / pooling stains present on flat roof. Recommend drainage improvements on flat roof to prevent water damage inside house.

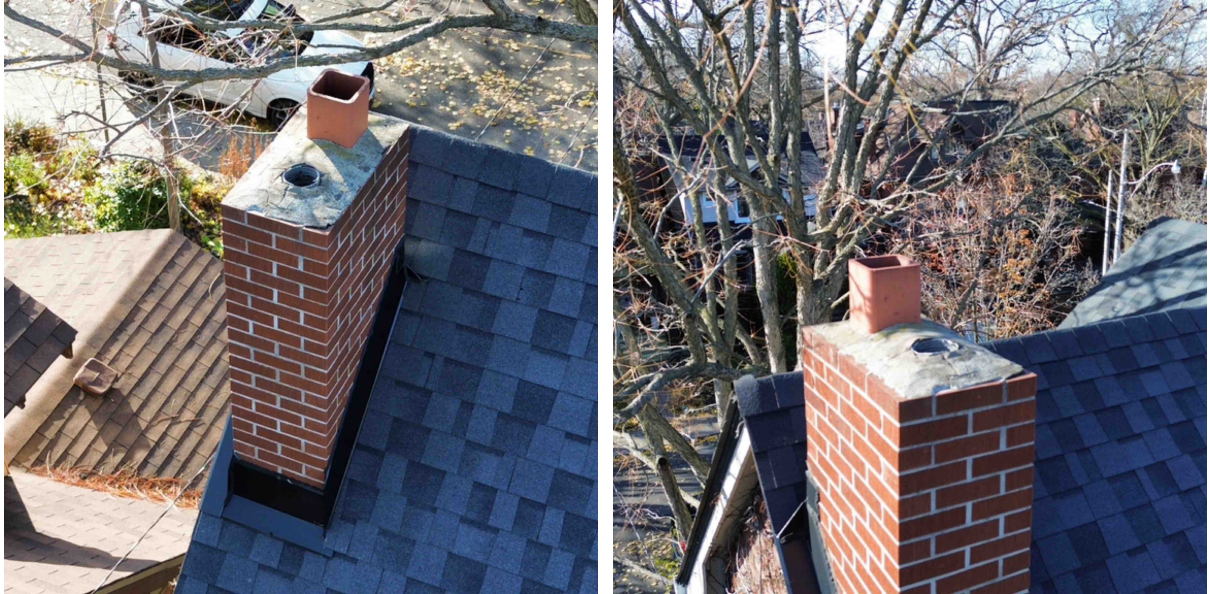
4.7.2 Recommend installing missing rain cap and screen to prevent water and animal entry into chimney.

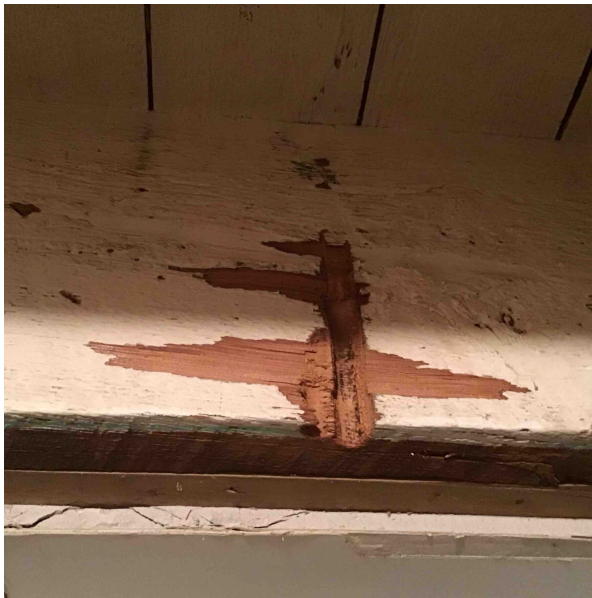
6.3.2 The joist(s) are improperly notched. Repair or replace the joist to restore structural integrity and safety.  
**(Storage Room)**

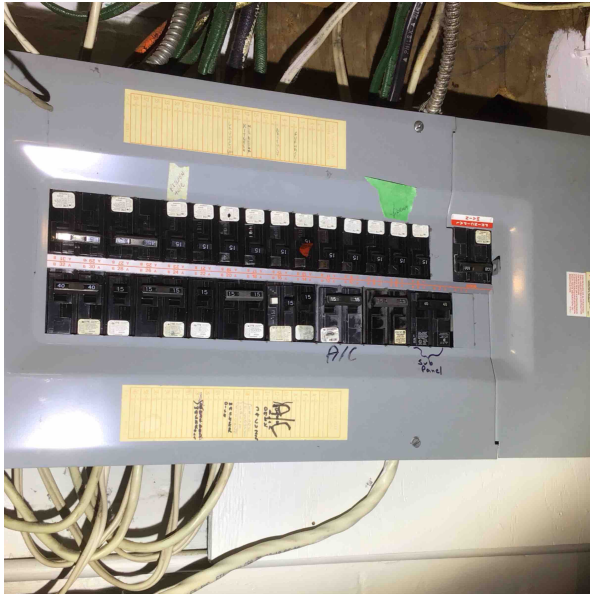
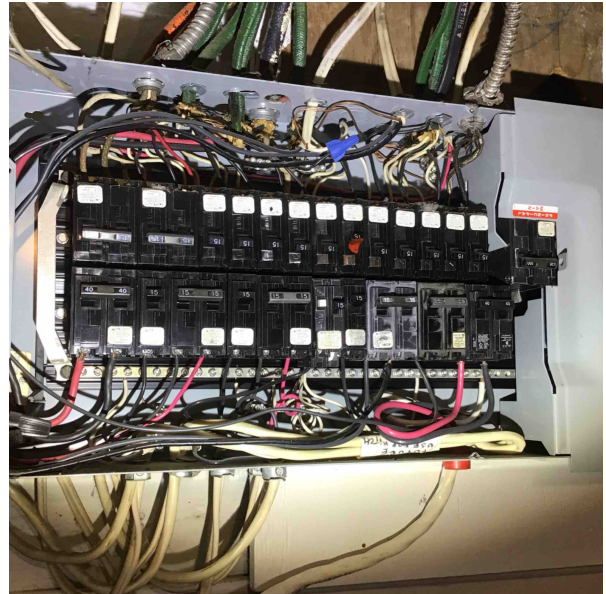
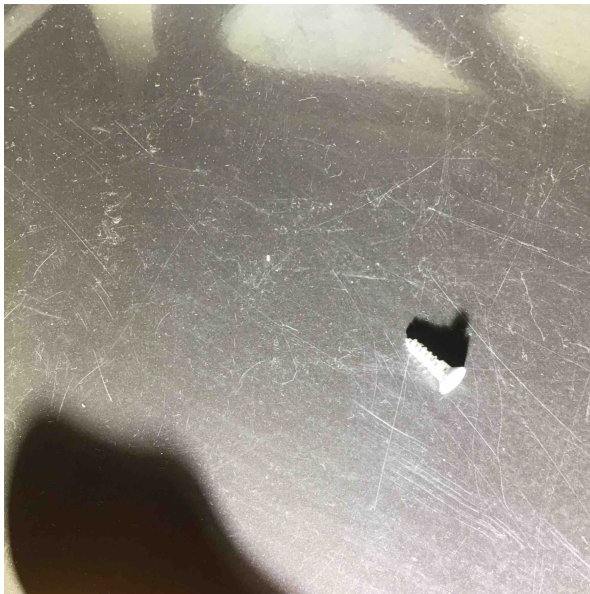
7.6.2 Two circuits were turned off

7.6.3 The panel cover screws are sharp, pointed screws. Replace these with blunt electrical panel screws to prevent damage to wires.

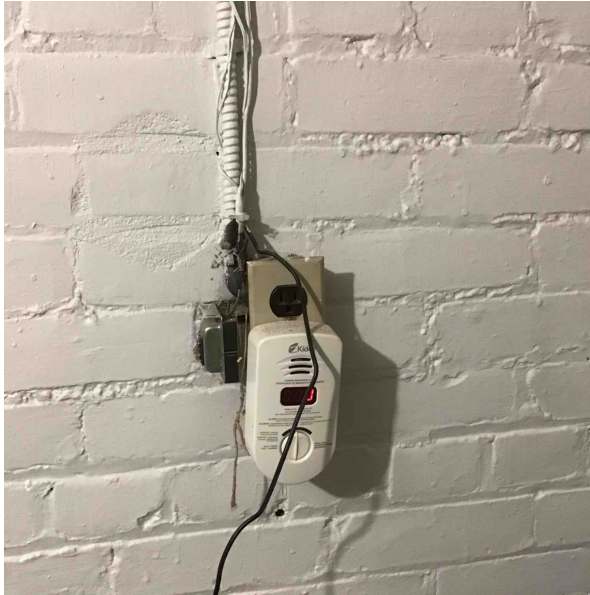
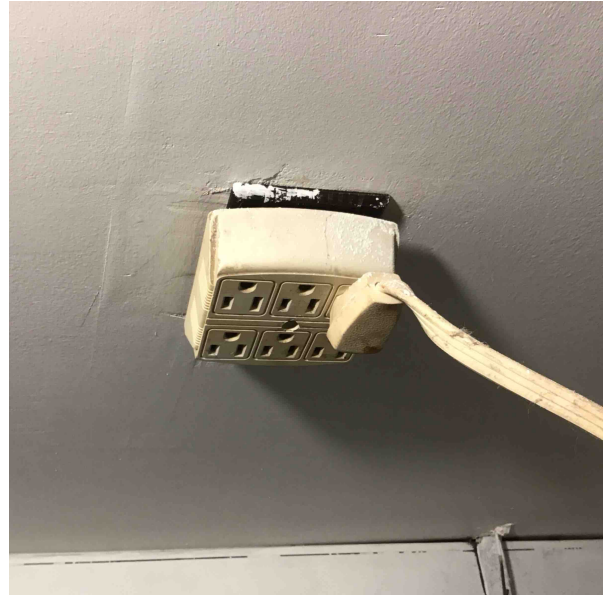
7.13.1 The GFCI(s) are missing. A qualified electrician should further assess and correct as required for electrical safety. **(Mechanical Room / Utility Room)**

**Missing GFCI near laundry equipment**

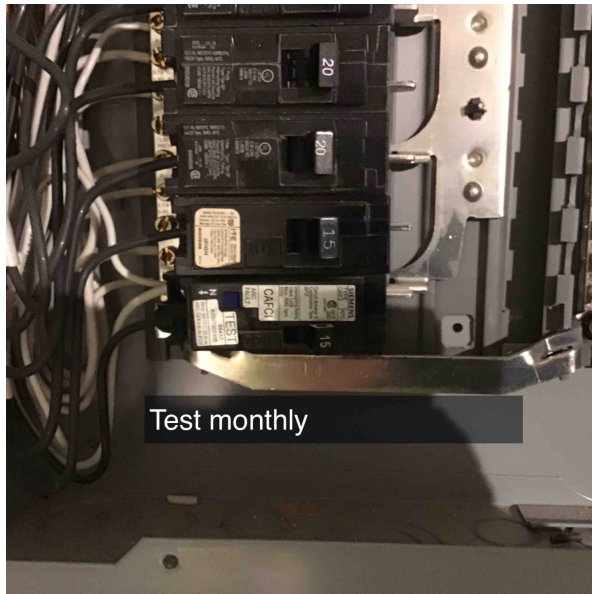
7.14.2 New electrical standards require AFCI circuits for all bedrooms. Add AFCI breaker(s) for safety in main panel. As per manufacturers' recommendations you should test AFCI breakers monthly and replace them if they fail to trip when tested.

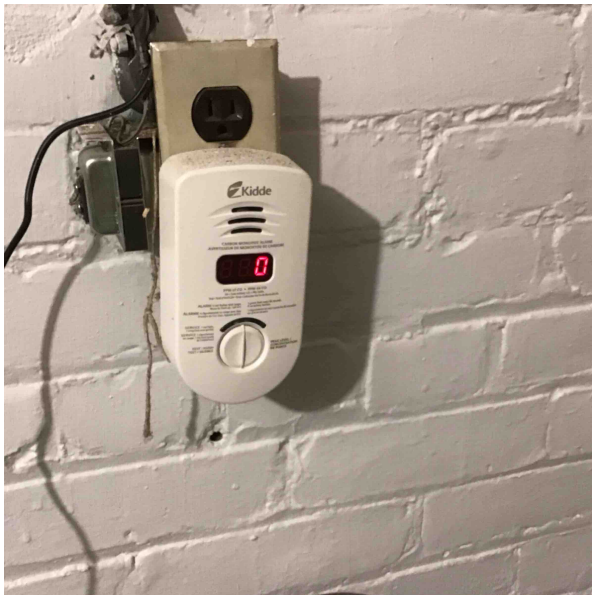
7.16.3 Consider replacing carbon monoxide alarms when taking possession to ensure that new, properly functioning and properly-located fire protection is in place. **(Mechanical Room / Utility Room)**

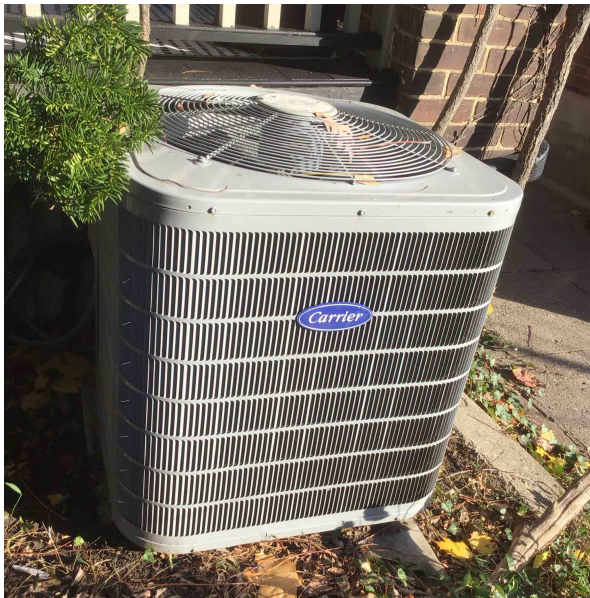
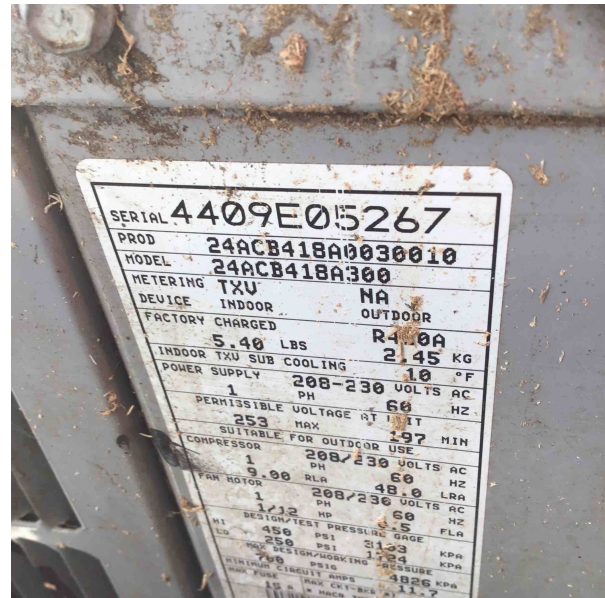
8.6.1 Air Conditioner is between the middle and end of its lifespan

8.6.2 The air conditioning system is near the end of its typical life expectancy. Replace the system when it fails, when repairs are no longer cost effective, or pro-actively to prevent loss of functionality. **(Exterior - Front)**

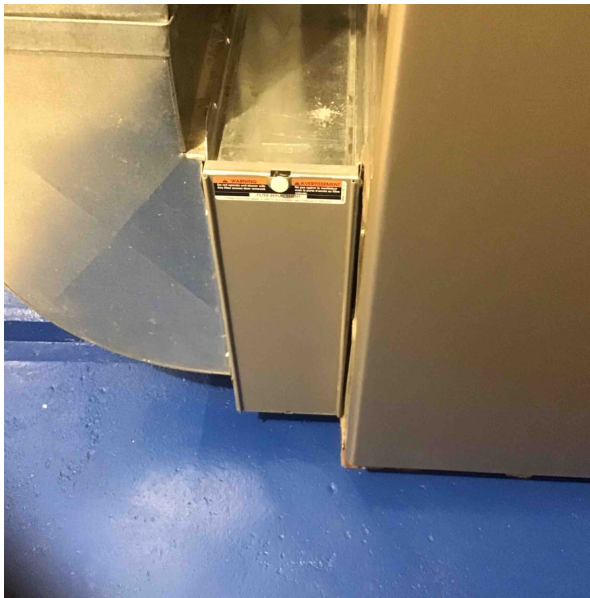
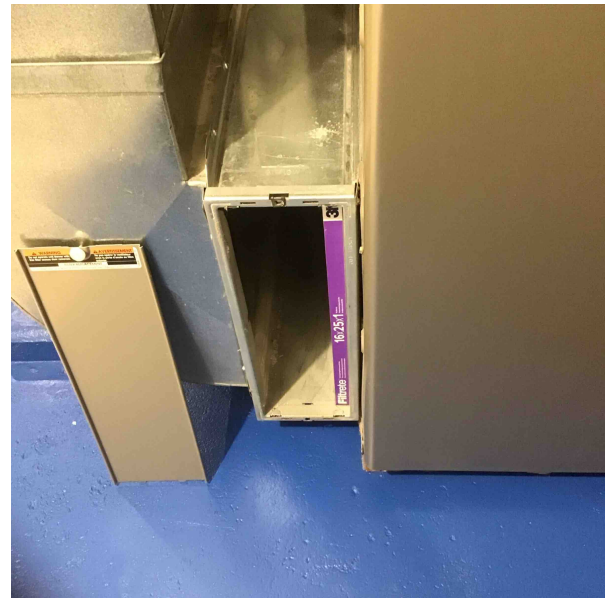
8.11.4 We would suggest that the furnace filter be changed or cleaned upon occupancy and monthly changes be performed. Dirty filters affect HVAC lifespan. **(Mechanical Room / Utility Room)**

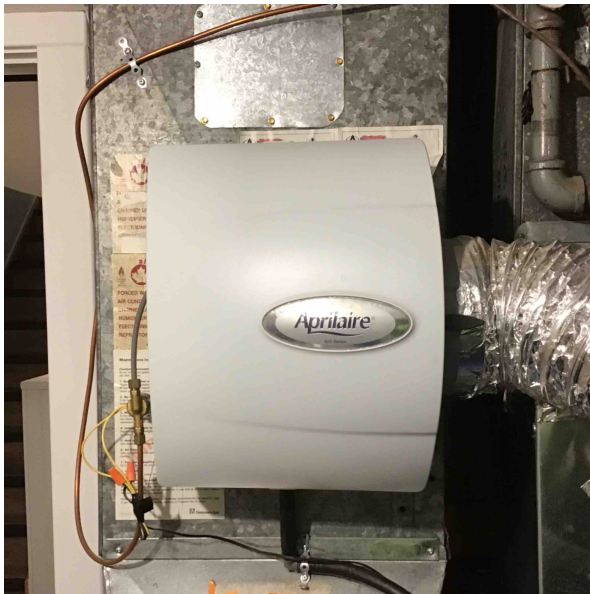
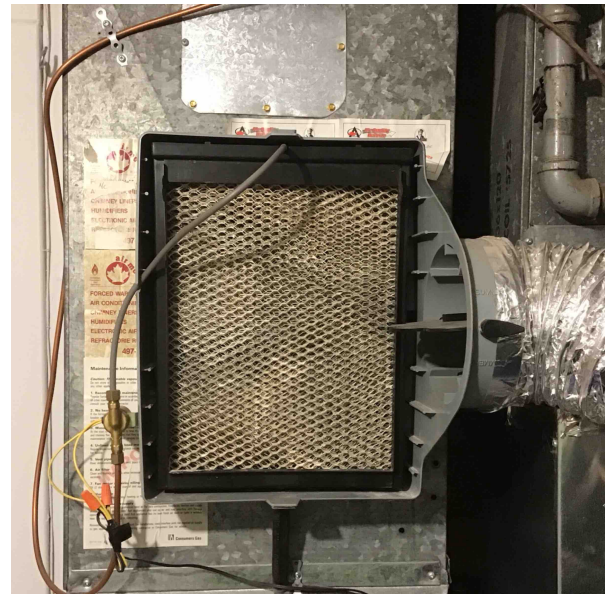
8.12.1 A humidifier is present, however the functionality was not determined. Have the unit assessed by an HVAC technician during annual servicing.

8.12.3 The HVAC system included a trickle humidifier that resolves winter dryness **(Mechanical Room / Utility Room)**

8.12.2 We would suggest yearly cleaning of the humidifier prior to the start of the heating system r

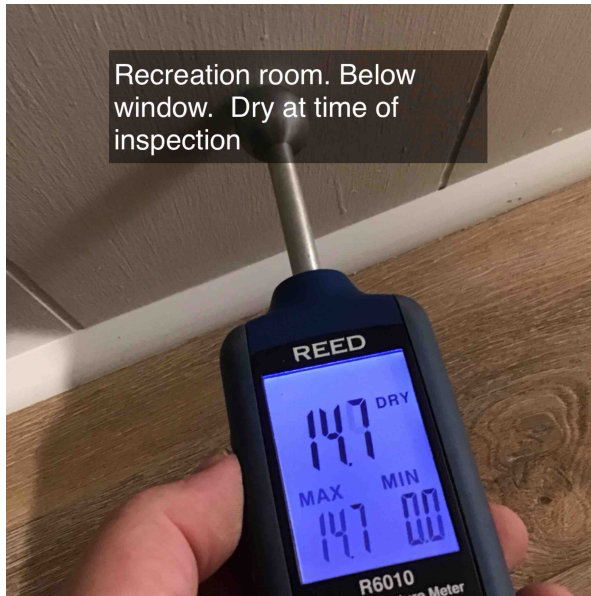
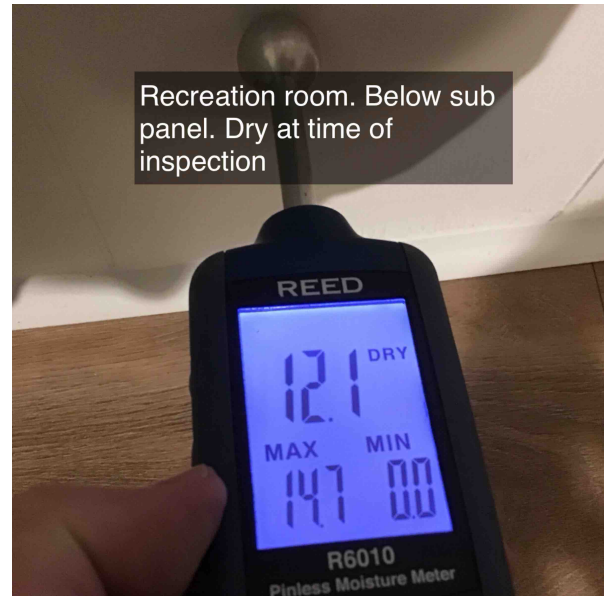
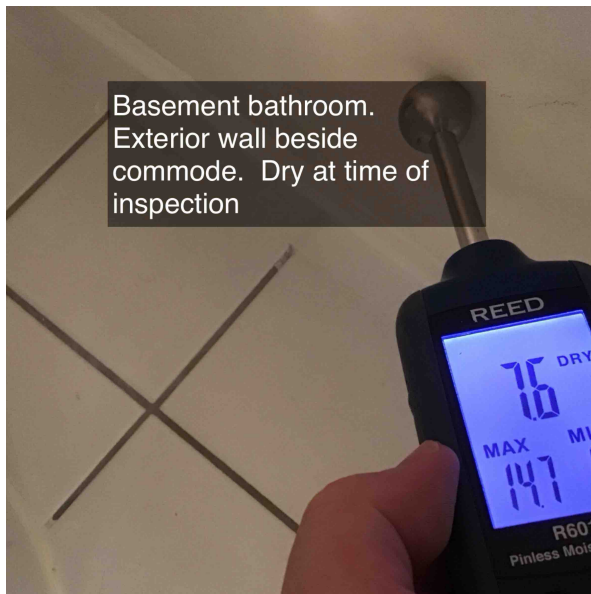
10.1.2 Water penetration: Active water seepage was not detected in the accessible areas of the basement. Most water problems are the result of non-functioning eavestroughs, downspouts, or poor surface drainage. We suggest that water not be allowed to pond beside the foundation.
